708P91374
June 2017

Xerox® VersaLink® B400 & B405 Family Multifunction Printer Service Manual

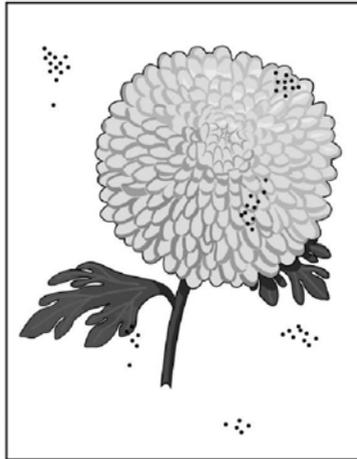
B-1-0307-A

There are spots of toner randomly scattered on the page, [Figure 1](#).

Figure 1 Random spots

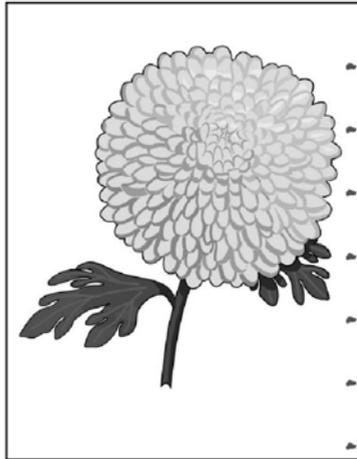
B-1-0309-A

Recurring dots or spots in the process direction, [Figure 1](#).

Figure 1 Pitched dots

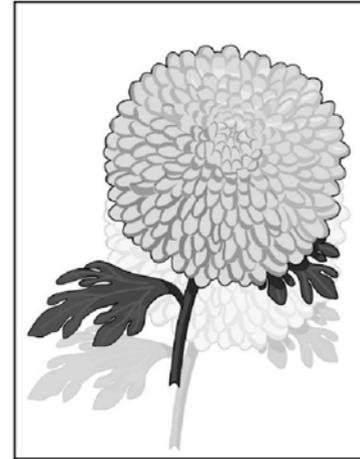
B-1-0311-A

The residual image from a previous print, or previous pager in the same print job appears on the current print, [Figure 1](#).

Figure 1 Ghosting

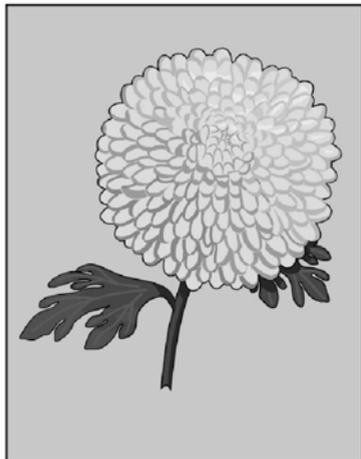
B-1-0313-A

There is toner contamination on all or part of the page, [Figure 1](#). The contamination appears as a very light dusting or fog.

Figure 1 Background defect

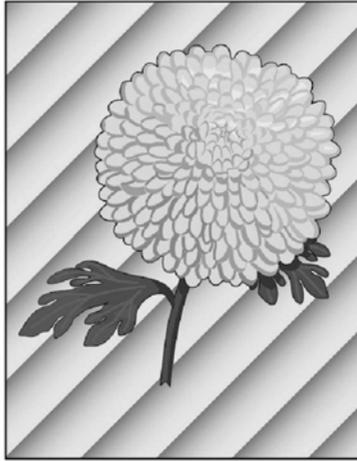
B-1-0317-A

Auger marks appear across output, [Figure 1](#).

Figure 1 Auger marks

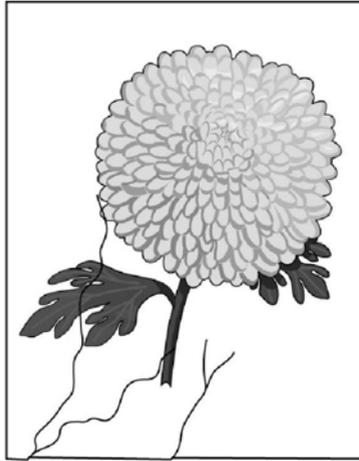
B-1-0318-A

Prints are either wrinkled, creased, stained or torn, [Figure 1](#).

Figure 1 Wrinkled paper
